Hydraulic State Agency  
Ankara

- Diagnostic-feasibility study
- Lake restoration by biomanipulation and metalimnetic aeration

# Comprehensive Lake Restoration

## Lake Management Planning

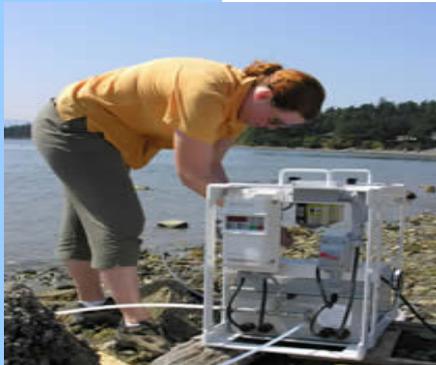
Gentek staff is shown installing runoff flow gaging and automatic sampling equipment. From the samples and data collected, we prepared annual hydrologic and phosphorus budget estimates for each of the five major lakes in the Goller region.

Most recently, we performed in-lake water quality modeling to determine the phosphorus mass released each year from anoxic lake sediments. In addition, sediment-water microcosm laboratory studies were completed to estimate the rate of anoxic sediment phosphorus release in each lake.

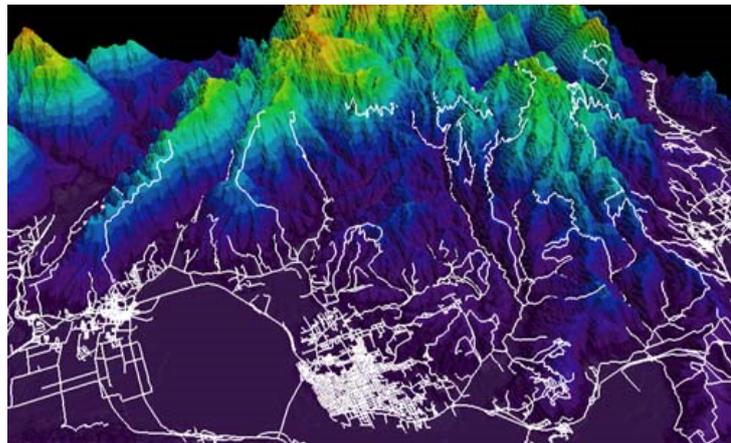
Left: Gentek prepared this geographic information systems (GIS) map of Beyşehir Lake to aid in the analysis of aquatic macrophyte (i.e., lake weed) data.

As part of the study, Gentek developed an experimental herbicide treatment program to control the curlyleaf pondweed's growth in the lake, as well as a detailed lake water quality monitoring program. Additionally, we developed a lake water quality management plan, an aquatic macrophyte plan, and a lake level control plan for the Beyşehir Lake Protection and Rehabilitation District.
